# Culvert Condition Study

Winnwood Road Bridge Class Culvert

**Town of Addison**

**May 28, 2020**

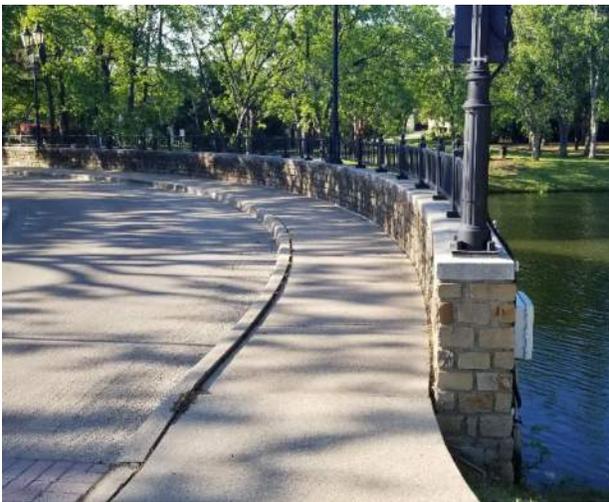
Photo 7: Rail End

The custom aesthetic pedestrian rail appears to be in good condition. It is not a standard TxDOT rail and is not likely crashworthy. A detailed inspection of the brick veneer was not performed, but no major structural deficiencies were observed. The end of the rail at the north approach has no end treatment for protection (See Photo 7 in Appendix A), but it is offset from the roadway 5’-6”. The desirable offset (Per TxDOT Roadway Design Manual) is 6’, but the minimum is 4’ for curbed sections; therefore, the existing condition would satisfy the minimum requirements for an obstruction being located outside the clear zone. There is no protection, however, for errant vehicles that may mount the sidewalk and approach the retention pond slopes.

The end of the pedestrian rail at the intersection of Winnwood Road and Belt Line has no end treatment and retention pond slopes are not protected with any means to keep errant vehicles from exiting the roadway and continuing down the slopes to the retention pond. The slopes are outside of the minimum clear zone for a curbed section, however Garver recommends extending the pedestrian rail on its own independent foundation (spread footing or grade beam) and wrapping around to the west along the sidewalk adjacent to Belt Line. This recommendation is not necessary or urgent but would provide additional safety for the traveling public.

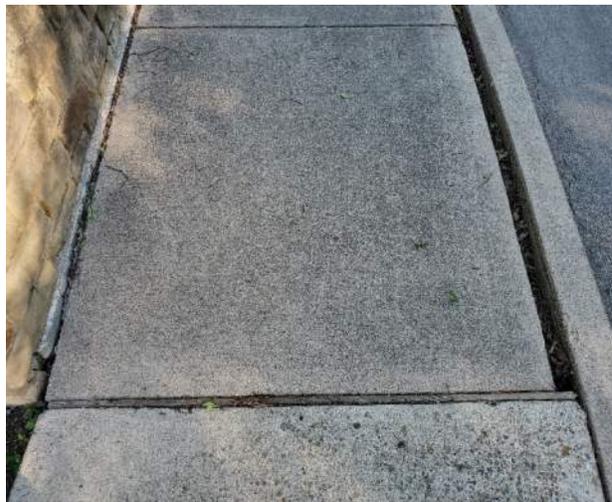
Photo 8: Sidewalk Joint

Concrete pavement approaches exist at the bridge class culvert ends. As detailed in the 2015 and 2017 inspection reports, there is minor cracking and light wearing of the pavement. Garver's site visit confirmed these conditions but did not observe any structural concerns for the integrity of the bridge class culvert itself. The sidewalk at the south approach has a gap of about 2 inches from the back of curb (see Photo 8 in Appendix A). This gap closes as the sidewalk continues north. It does not appear that the embankment walls and pedestrian rail adjacent to the sidewalk are moving to cause this separation; rather it appears the sidewalk was not constructed to its full width at this location. No structural concerns exist with the sidewalk separation; however, it may provide a tripping hazard for pedestrians.

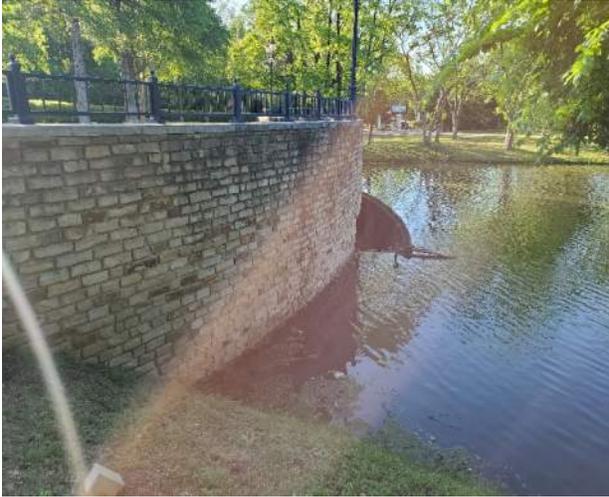
Photo 9: Upstream Channel Banks (North)

The upstream end of the bridge class culvert is a retention pond. The pond slopes at the bridge class culvert are grass lined and show no significant erosion (See Photos 9 and 10 in Appendix A).

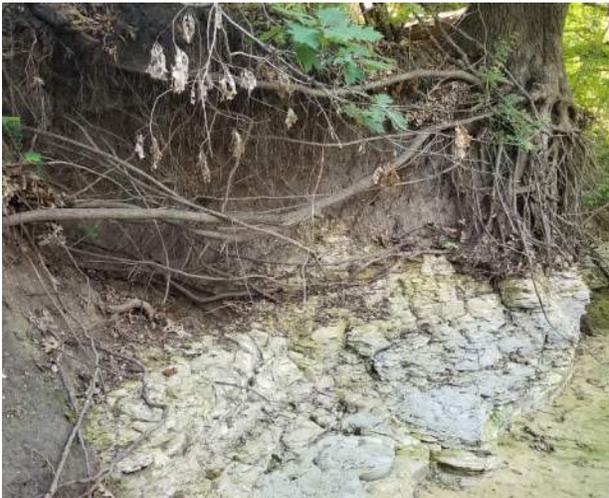
Photo 11: Downstream Channel Banks (North)

The existing channel bed at the downstream end consists of exposed weathered limestone rock overlain with sediment (See Photos 11 and 12 in Appendix A). As detailed in the 2015 and 2017 inspection reports, moderate scour and undermining at the outlet toewall and wingwalls is present (See Photo 13 in Appendix A). Garver's site visit confirmed these conditions. Furthermore, it appears, at some time, there was concrete riprap between the bridge class culvert wingwalls and toewall but has been dislodged at least since the 2015 inspection (See Photo 14 in Appendix A).

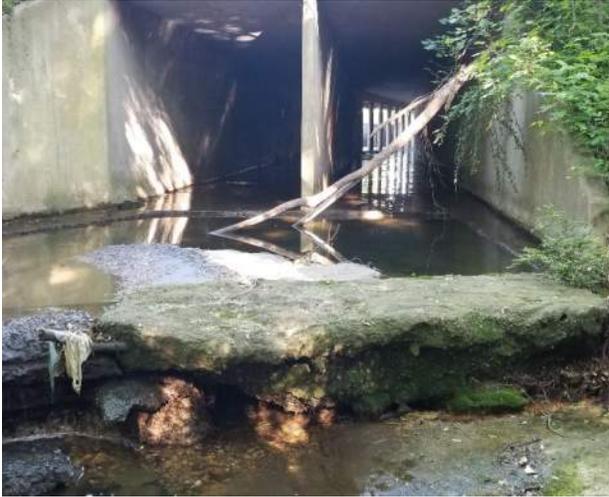
**Photo 13: Scour and Undermining**

Garver recommends removing the dislodged concrete riprap at the downstream end of the bridge class culvert. New riprap in the form of concrete apron, stone protection, or a combination of the two should be constructed with a key into the existing channel to protect against further scour and undermining of the wingwalls and toewall. A hydraulic analysis should be performed to determine the outfall velocities so that the riprap can be sized appropriately. The progression of the scour since 2015 and 2017, based on photos in the inspection reports, has not worsened appreciably, and repair is not urgent. However, the condition of the channel banks and erosion should be monitored with routine inspections to determine if immediate action is needed.

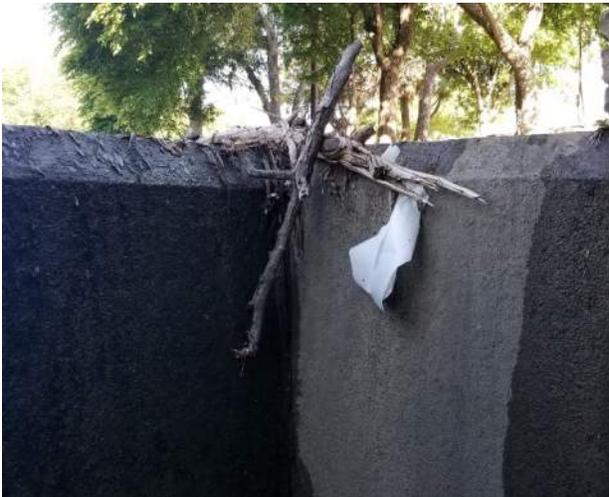
Minor debris build-up is present at the upstream spillway (See Photo 15 in Appendix A) and at the downstream outfall (See Photo 16 in Appendix A).

**Photo 15: Spillway Debris**

The debris at the upstream spillway and at the downstream wingwalls should be cleared to provide a clear path for hydraulic flow.

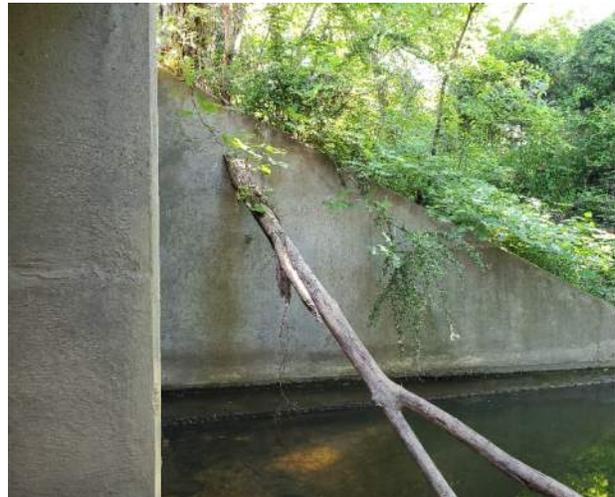
**Photo 16: Downstream Debris**

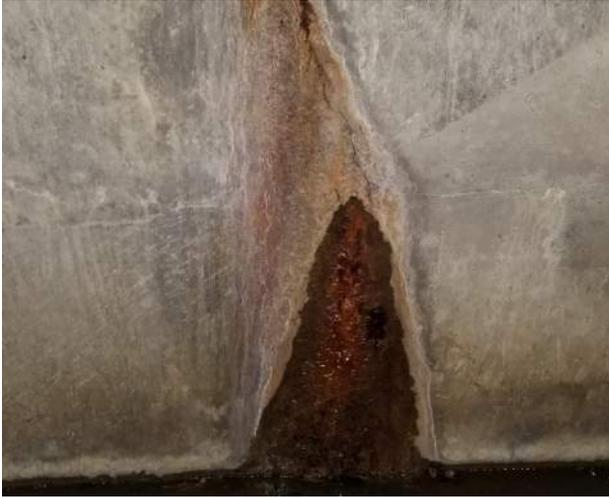
As detailed in the 2015 and 2017 inspection reports, there are minor vertical and horizontal hairline cracks with efflorescence in the culvert walls and slabs which are common in culverts of this age. Garver's site visit confirmed these cracks (See Photos 17 and 18 in Appendix A) and did not reveal any major structural deterioration.

Photo 17: Vertical Crack in Wall With Efflorescence Build-Up

No repairs are necessary or recommended at this time for the minor cracks observed. Routine inspection will continue to monitor the concrete elements and elevate the need for repairs should advanced distress be observed.

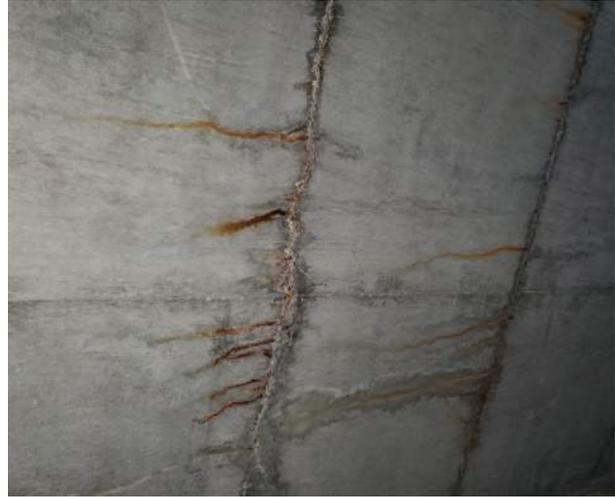
Photo 18: Transverse Crack in Top Slab with Efflorescence

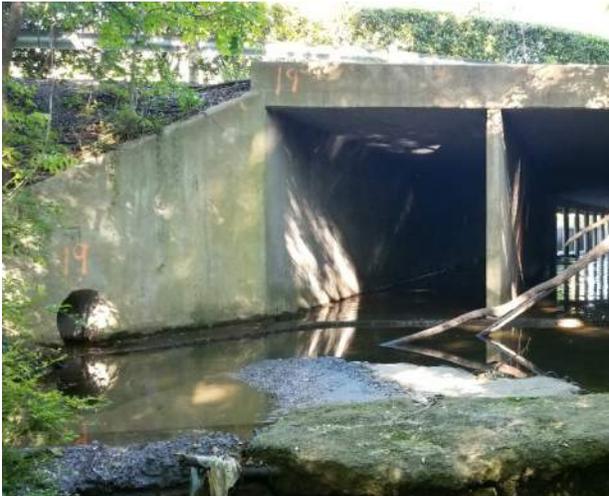
Photo 19: Wingwall and Headwall

As detailed in the 2015 and 2017 inspection reports, the west headwall has minor impact spalls. The east headwall has a minor vertical crack. Garver's site visit did not reveal any major structural deficiencies with the wingwalls and headwall.

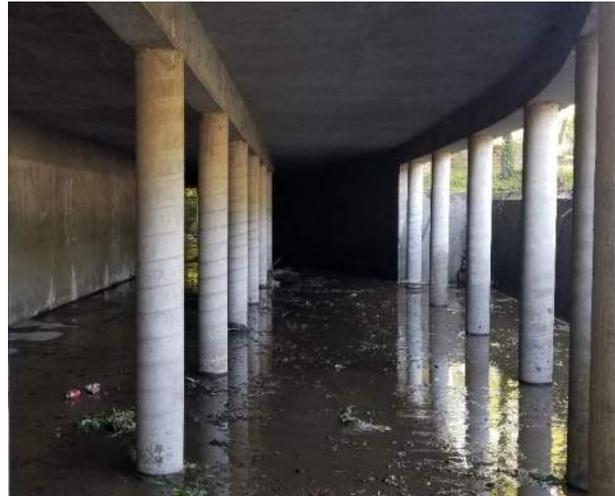
Photo 20: Culvert Columns at Spillway

As detailed in the 2015 and 2017 inspection reports, the interior columns have minor scaling at the bottom. Garver's site visit did not reveal any major structural deficiencies with the columns.
