FIVE-YEAR CAPITAL IMPROVEMENT PLAN FOR WATER STORAGE FACILITIES

**Celestial 6 MG Ground Storage Tank, Surveyor 2 MG Ground
Storage Tank, & Addison Circle 1 MG Elevated Storage Tank
Addison, Texas**

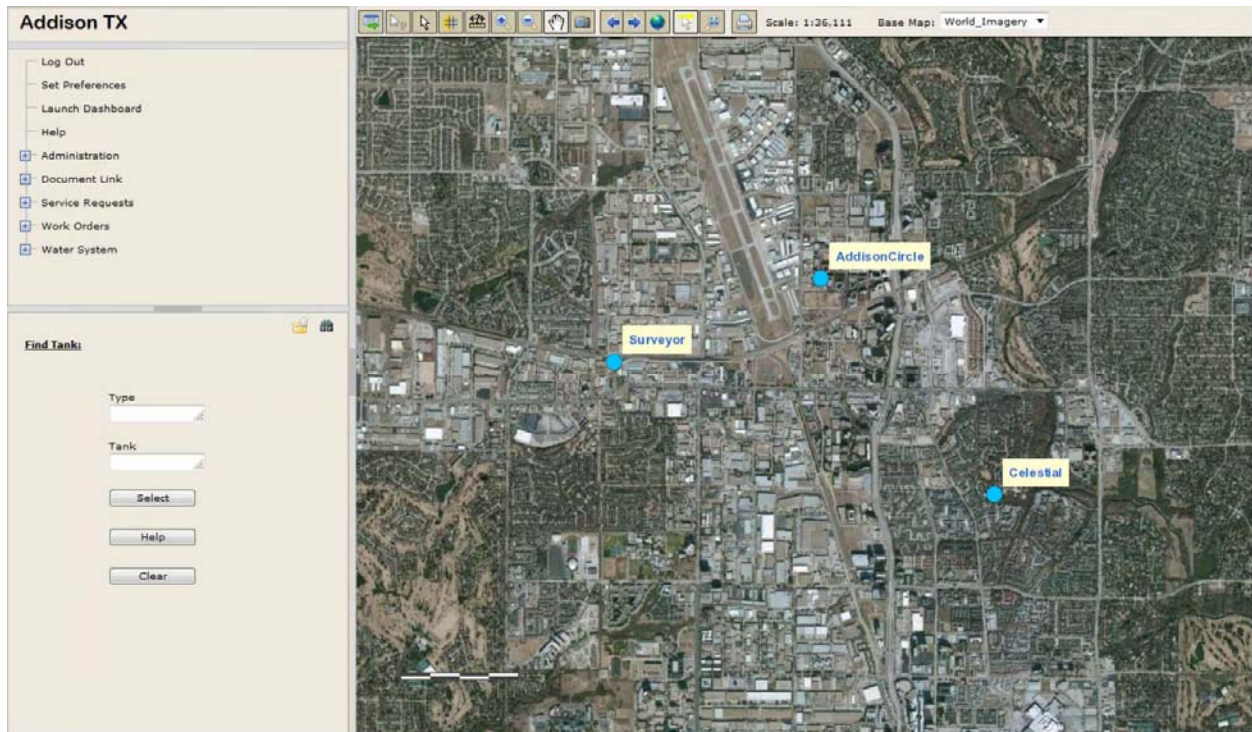
- Preventive maintenance nexus to premature capital investments:** One cannot discuss capital needs planning without thoughtful consideration of the allocation of resources for maintenance. The figure below depicts the typical deterioration of a facility with no maintenance and repair done to it during its projected life. However with an appropriate level of maintenance at the proper time, the deterioration curve can be shifted to the right, indefinitely. This has significant financial implications for the Town trying to manage assets having a replacement value approaching millions of dollars. As the curve depicts, by forgoing relatively inexpensive maintenance, in the course of a few years, the capital dollars needed to return facility back to its operational potential, become exponential.

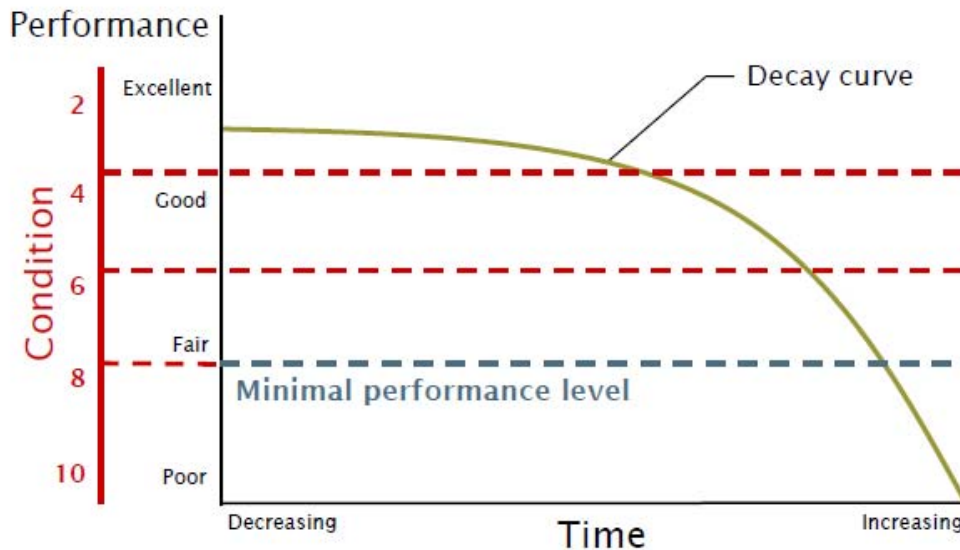
Water Storage Facility Project Costs

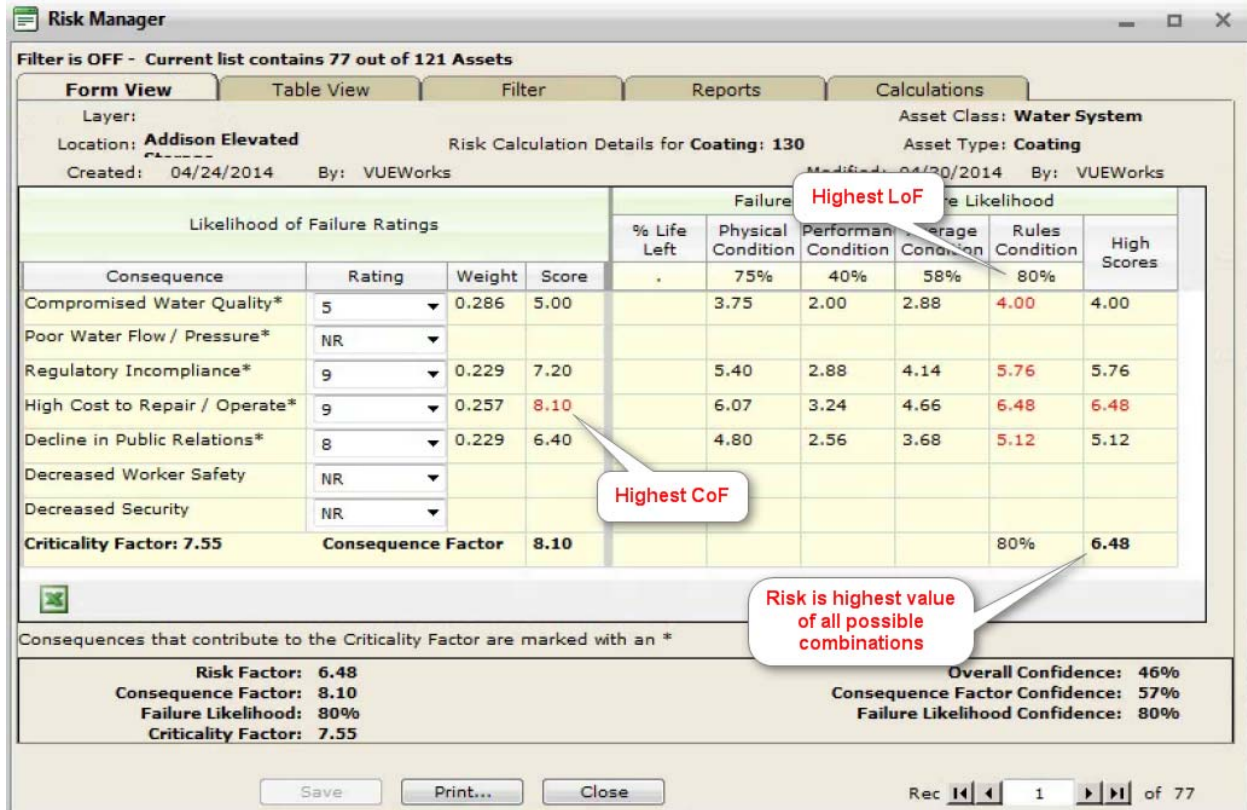
Once Risk is calculated for each asset the results can be presented in a number ways including a prioritized list or plotted in a quadrant graph as shown below. The quadrant the asset falls within provides guidance on how to proceed with each asset as follows:

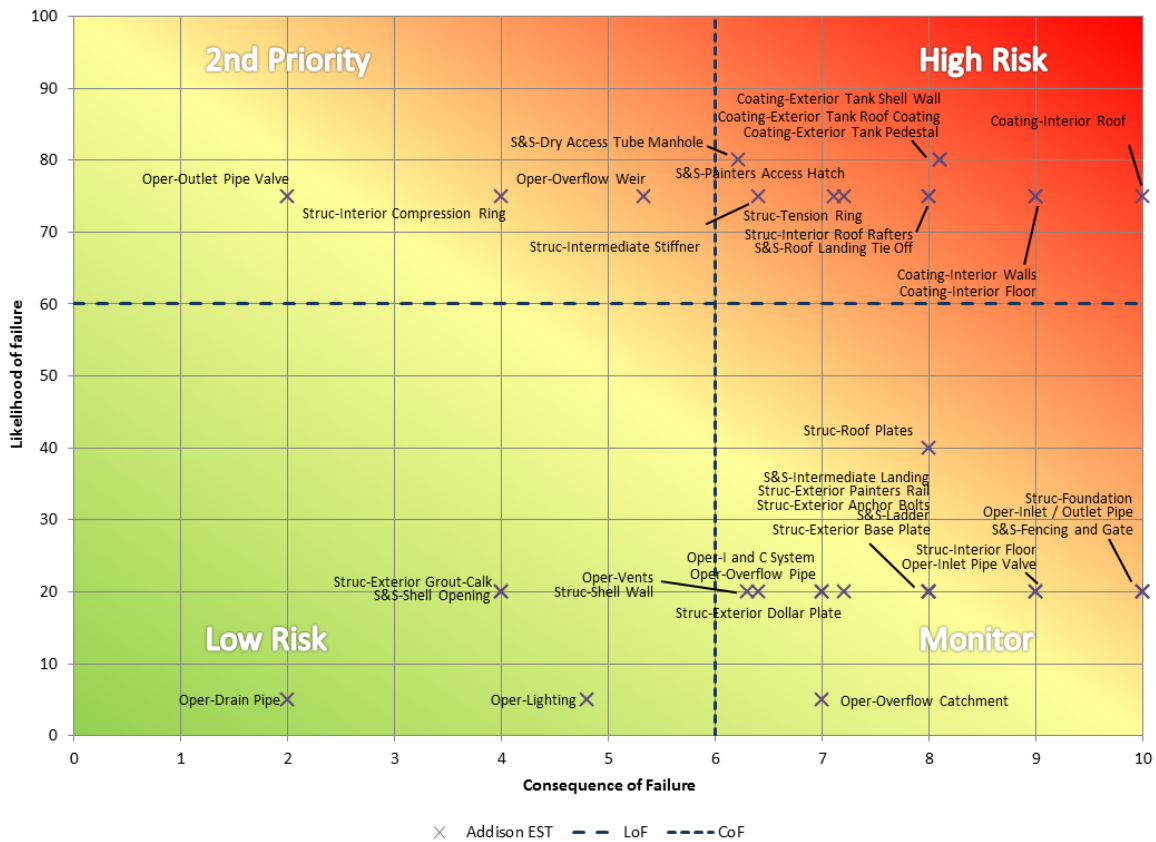
Referring to the prioritization grid above, if a coating is in poor condition, the likelihood of a coating failure leading to a consequential tank roof leak could be very high for a metal tank but has much smaller risk associated with a concrete tank (because concrete does not corrode as metal does).

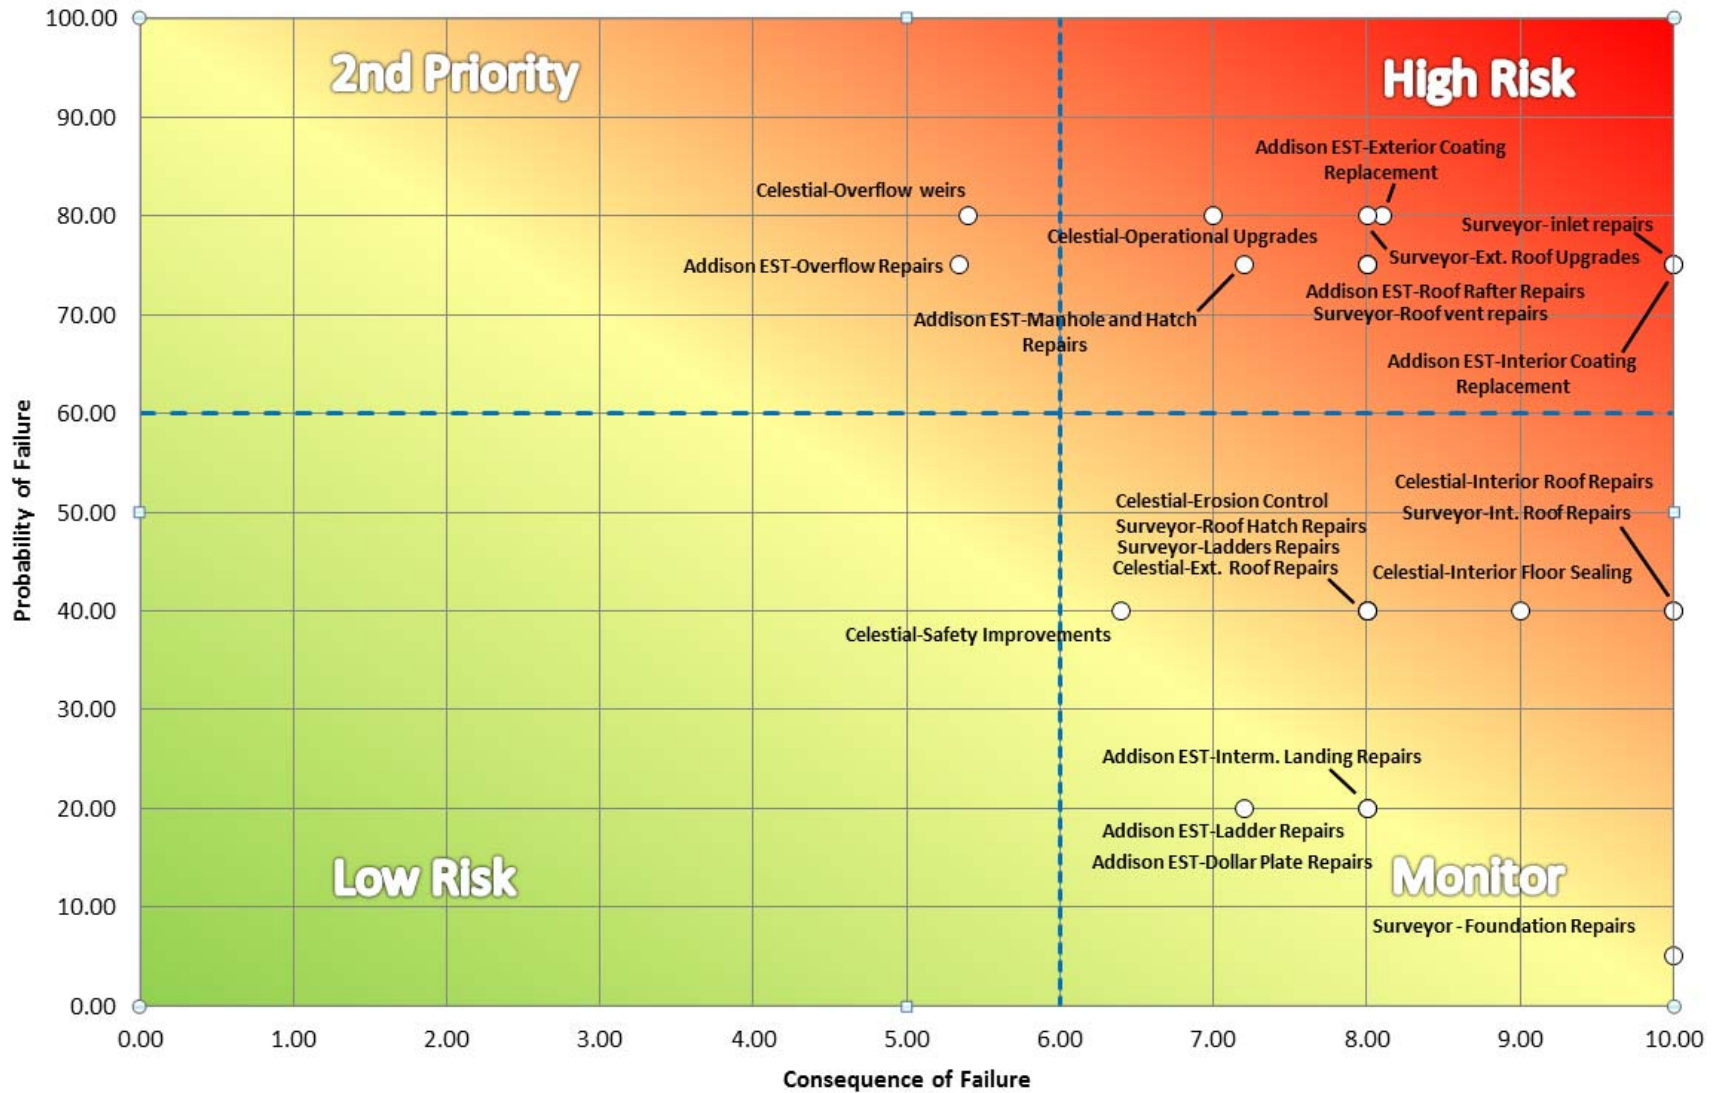
Total Project Costs by Tank
