Les Lacs Pond Liner Replacement & Water Quality Update

June 11, 2019

Presentation Overview

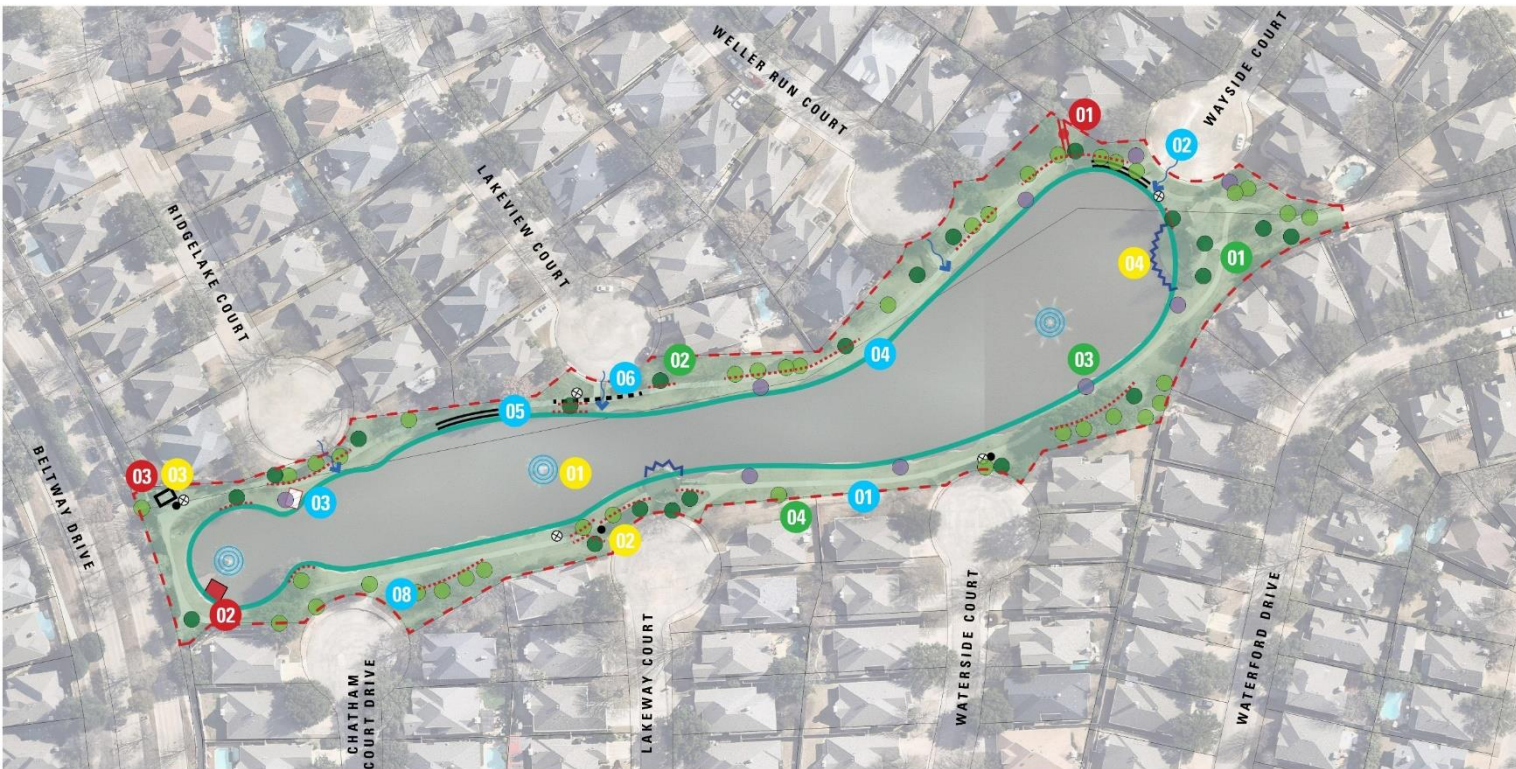
Background Information - Existing Conditions

- 01 PROPERTY BOUNDARY
- 02 CONCRETE FLUMES
- 03 LIMESTONE SUB-LAYER
- 04 AGING IRREGULAR POND EDGE
- 05 STEEP SLOPES
- 06 WALK NOT ADA ACCESSIBLE

- Upland Pond, 2.2 Acres.
- Residents report concerns with water quality.
- Manages stormwater for surrounding neighborhood.
- Irregular concrete edge, deteriorated.
- Steep slopes in some areas.
- Liner is nearing or has exceeded its life expectancy of 15-20 years.
- Two constructed overlooks with water recirculation.

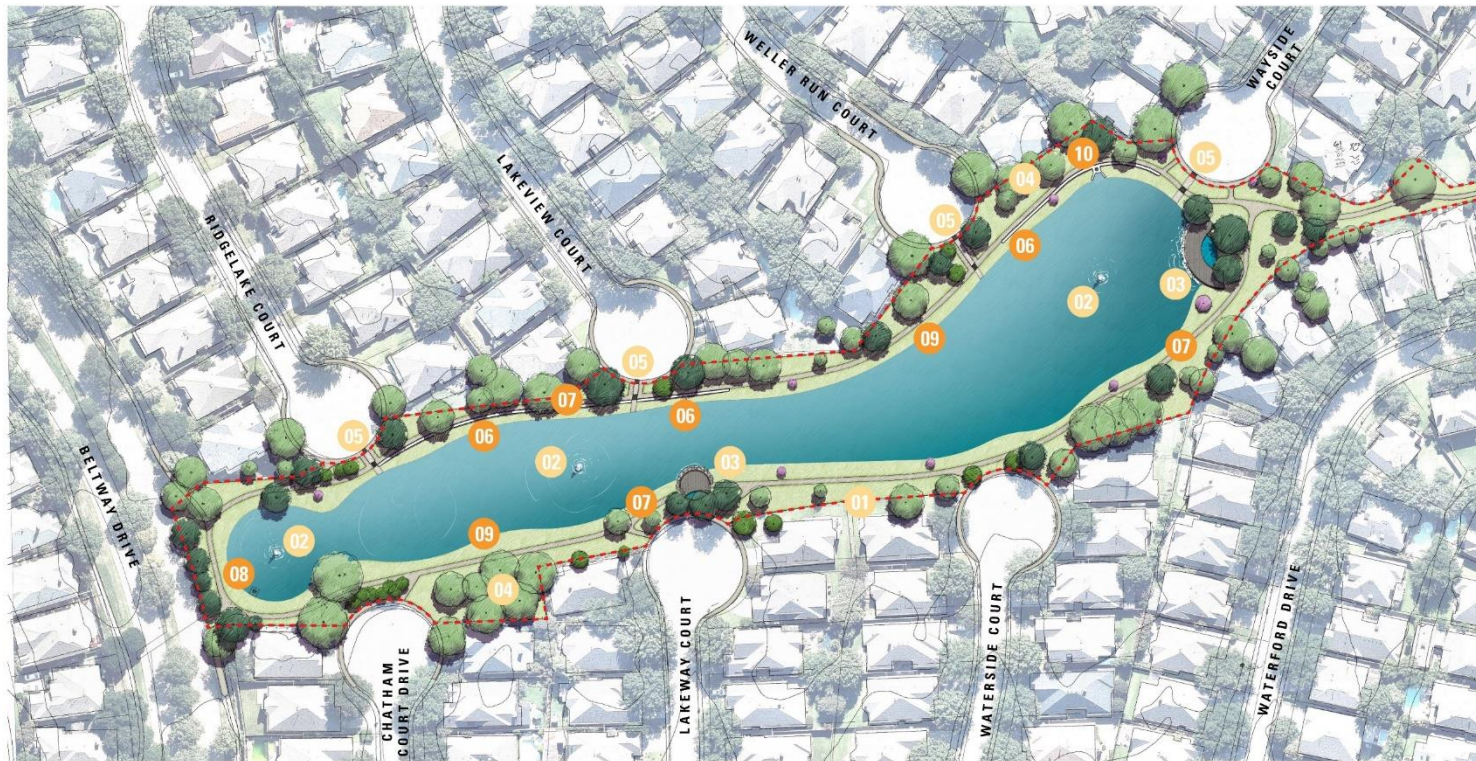
Background Information - Base Option

- 01 PROPERTY BOUNDARY
- 02 EXISTING FOUNTAINS
- 03 EXISTING DECK AND WATERFALL
- 04 EXISTING TREES TO REMAIN
- 05 EXISTING CONCRETE FLUME
- 06 PROPOSED RETAINING WALLS
- 07 MAKE WALK ADA ACCESSIBLE
- 08 PROPOSED POND OVERFLOW TRASH RACK
- 09 PROPOSED SMOOTHING OF ENTIRE PERIMETER POND EDGE
- 10 APPLY STONE VENEER TO OUTFALL STRUCTURE

NOTES:
OPTION 1 INCLUDES THE MINIMUM WORK REQUIRED TO REPLACE THE LINER, MEET ADA REQUIREMENTS AND SMOOTH OUT THE POND EDGE TO IMPROVE MAINTENANCE.

Base Option Includes the Minimum Work Required to Replace the Liner, Meet ADA Requirements, Smooth Out the Pond Edge to Improve Maintenance and Revegetate the Site to Existing Conditions

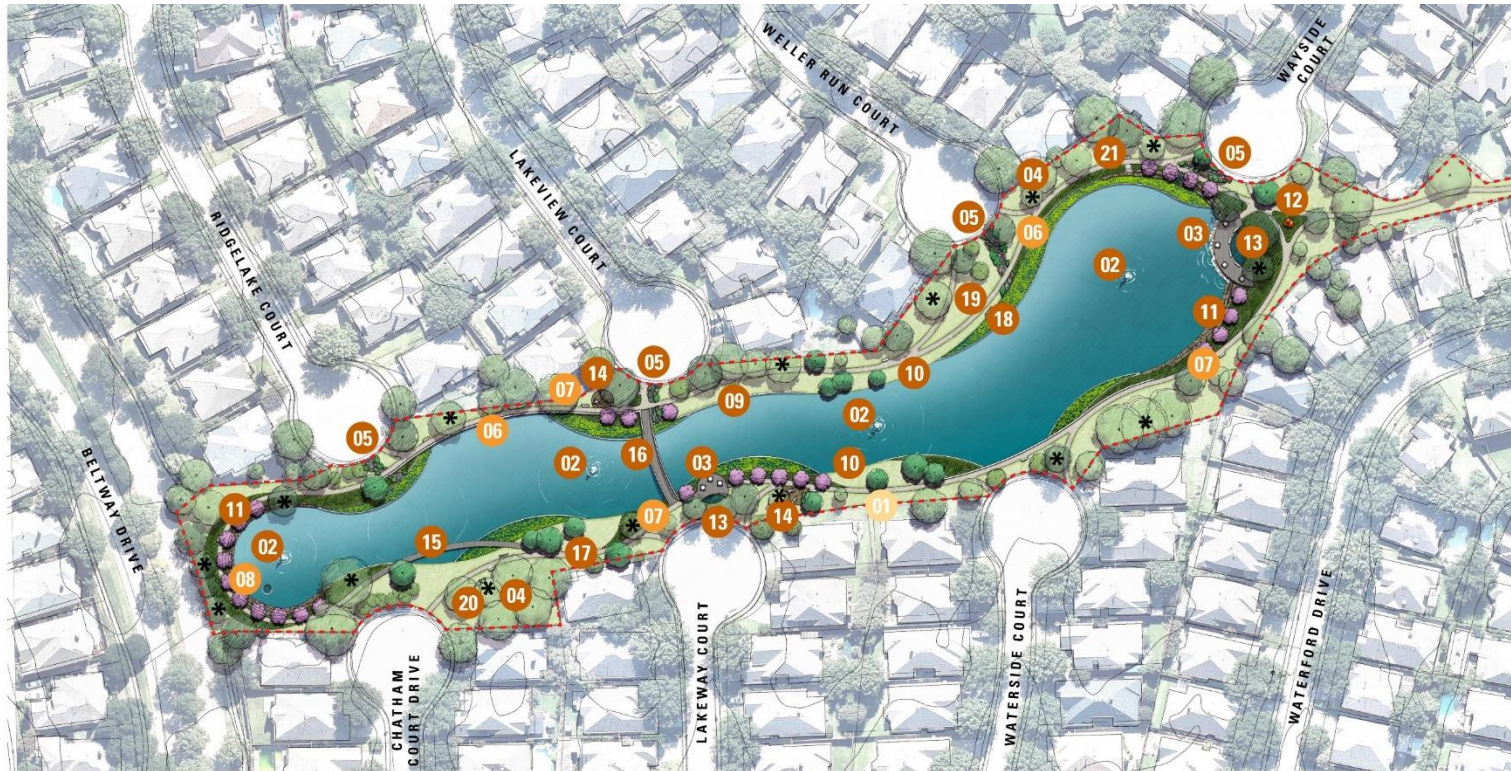
Background Information - High Option

| 01 PROPERTY BOUNDARY | 07 WIDEN WALKS TO 8' AND CREATE CURVILINEAR ALIGNMENT | 13 EXISTING DECKING WITH PROPOSED MOVABLE SEATING AND GAME AREA | 19 PROPOSED EDUCATIONAL SIGNAGE |
| 02 NEW FOUNTAINS WITH LED LIGHTING | 08 PROPOSED POND OVERFLOW TRASH RACK | 14 PROPOSED FITNESS STATIONS ALONG WALK | 20 PROPOSED ROOT BARRIER TO PROTECT SIDEWALKS AND POND LINER |
| 03 EXISTING WATERFALL WITH PROPOSED LED LIGHTING AND CLEANING OF ROCKS | 09 PROPOSED SMOOTH POND FORM AND CONCRETE EDGE | 15 PROPOSED BOARDWALK | 21 NUTRIENT/DEBRIS COLLECTION CHAMBER |
| 04 PRESERVE EXISTING TREES AND ADD UPLIGHTING (*) | 10 PROPOSED SMOOTH POND FORM AND NATURAL LANDSCAPE EDGE | 16 PROPOSED BRIDGE | |
| 05 EXISTING CONCRETE FLUME WITH PROPOSED RAIN GARDEN AND STONE BOULDERS | 11 PROPOSED SMOOTH POND FORM AND STONE EDGE | 17 PROPOSED MEANDERING WALK | |
| 06 PROPOSED RETAINING WALLS | 12 PROPOSED ART | 18 PROPOSED AQUATIC PLANTING | |

OPTION 2 INCLUDES ITEMS SHOWN IN OPTION 1 AND RECOMMENDED ENHANCEMENTS. THE ENHANCEMENTS WILL BE PRIORITIZED BY COMMUNITY INPUT.

High Option Builds on the Base Option and Includes the Stone Edge Option, Additional Plantings, Interactive Amenities, Site Improvements, Environmental Amenities and Aesthetic Amenities.

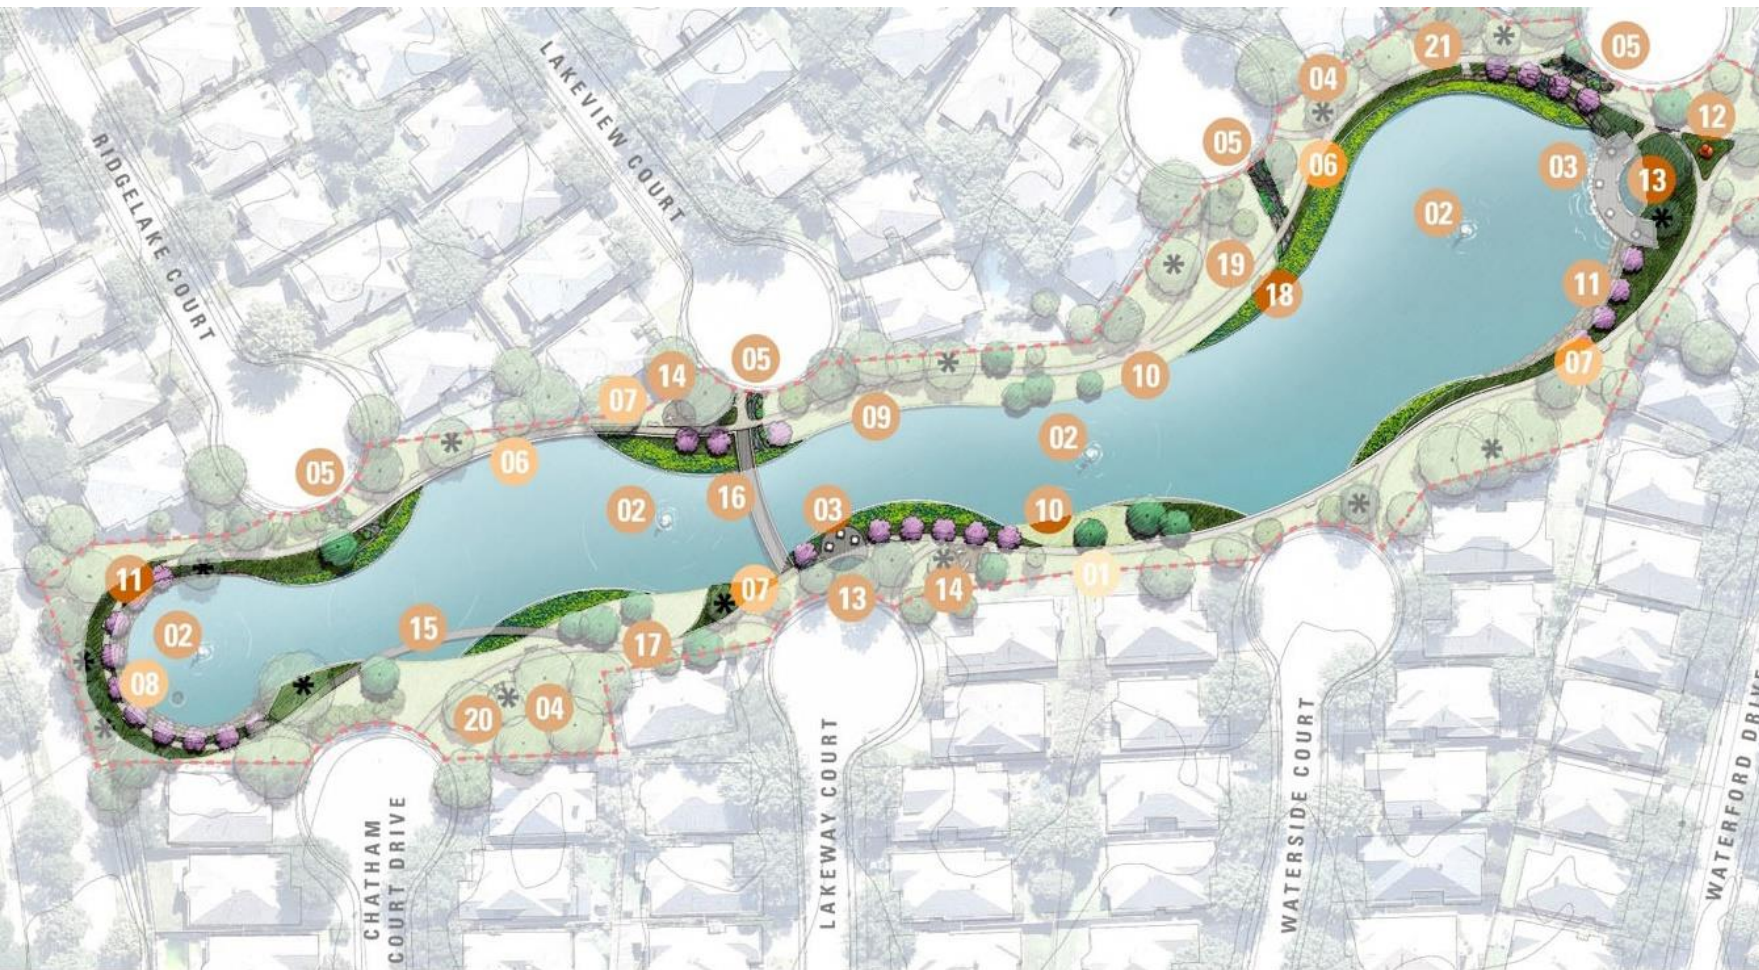
Question 2 - Landscape Breakdown

Additional Landscape Includes:

Fine Grading
Bed Preparation
Shrub and Groundcover
Additional Sod Replacement
Canopy Trees
Ornamental Trees
Root Barrier
Steel Edging
Spray Irrigation
Drip Irrigation
Irrigation Meter
1-Year Maintenance
