Addison Airport Customs and Border Protection Facility Change Order No. 3

Staff Presentation

October 13, 2020

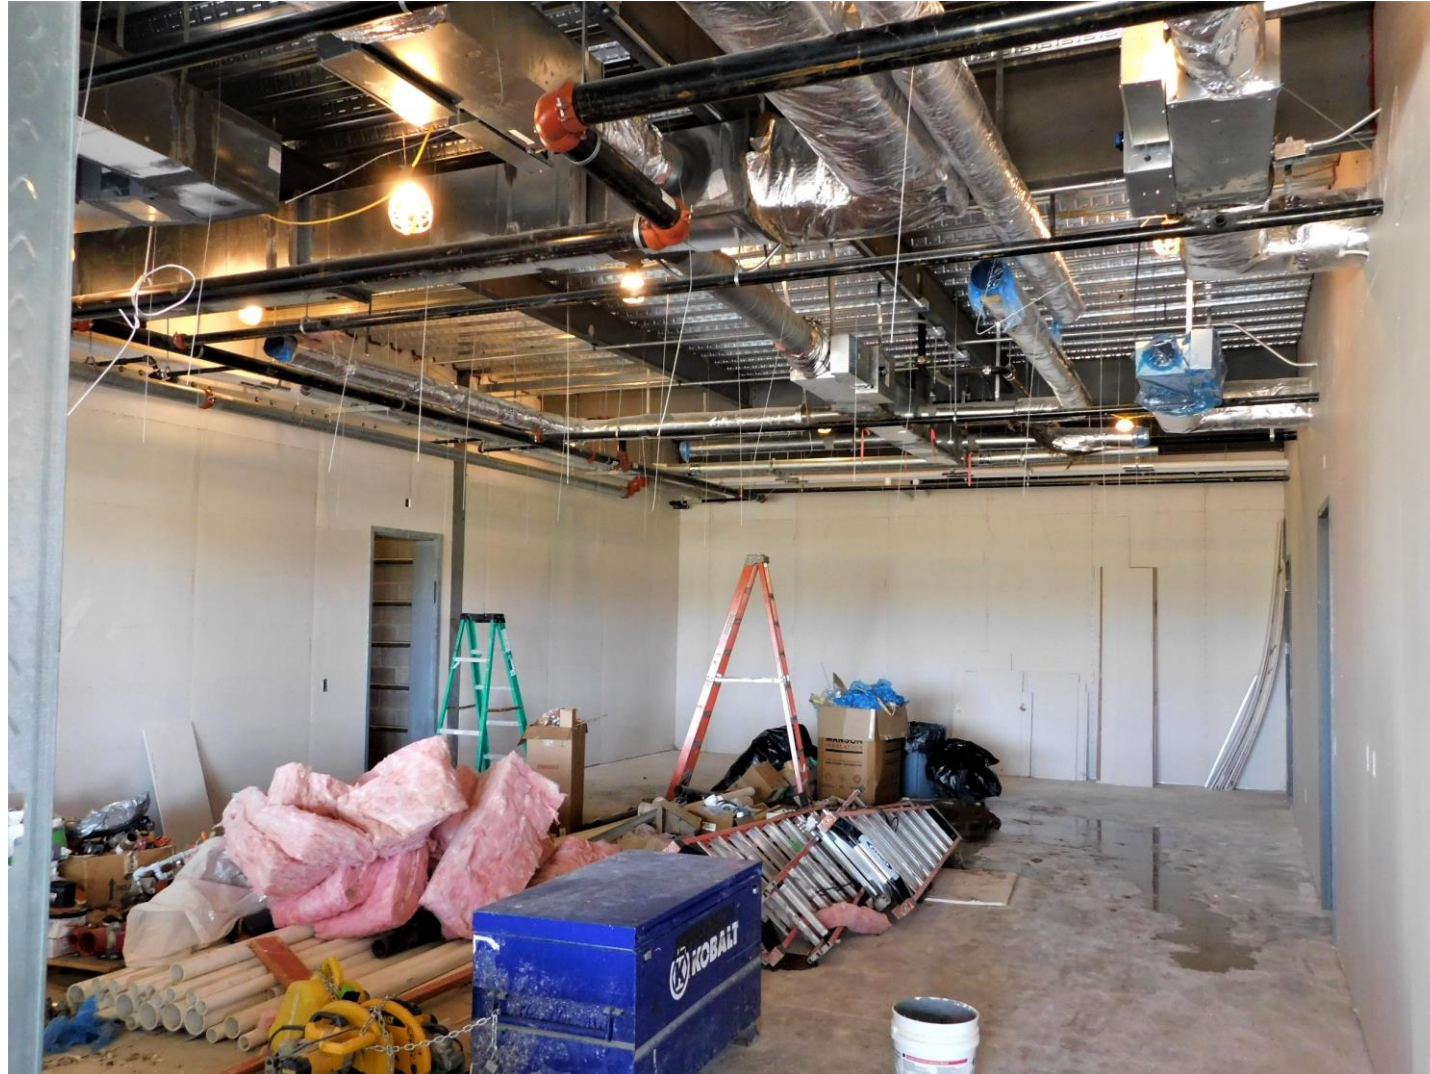
First floor processing area (September 25, 2020).

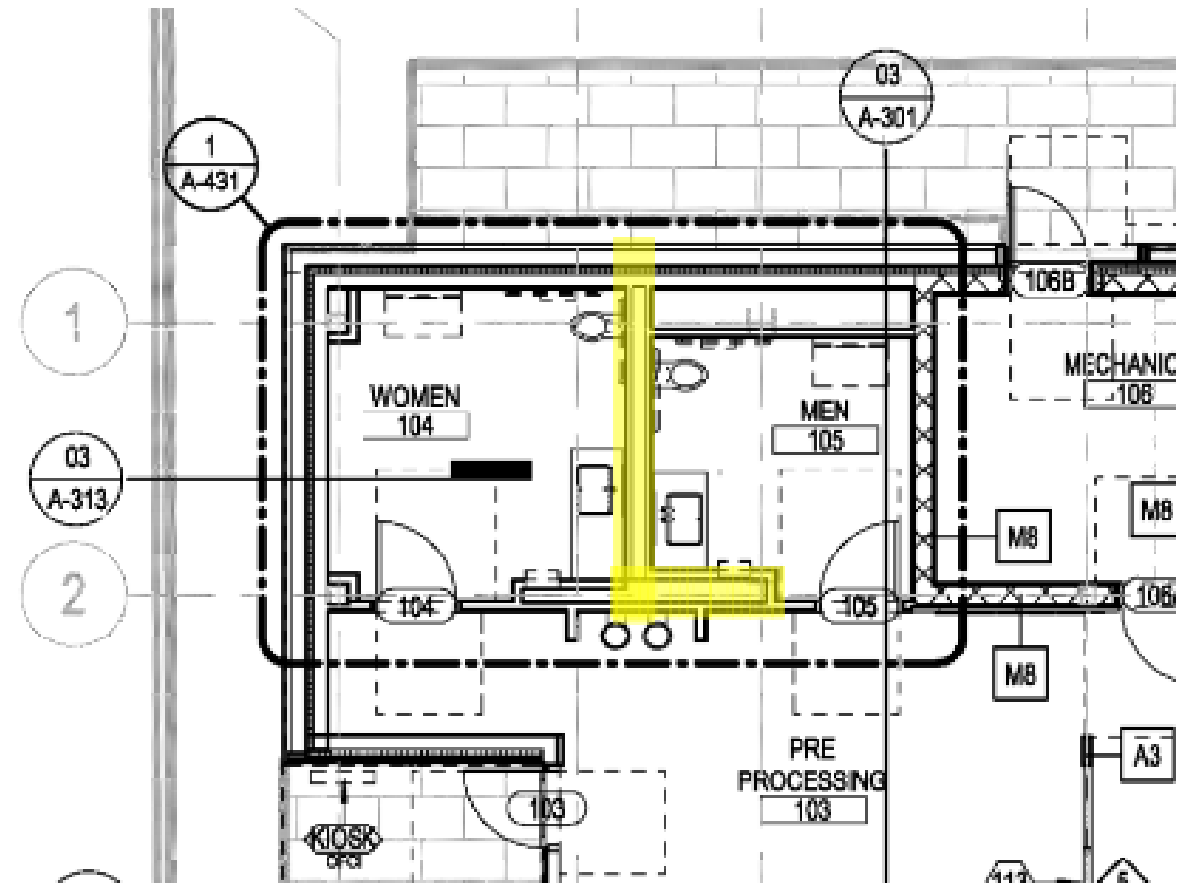
- First floor wet wall plumbing chase between 'Women 104' and 'Men 105'
 - Plumbing chase depth was too narrow to accommodate the back to back toilet carriers and any plumbing crossovers
- The contractor was directed to expand the width of this chase and modify its extents to provide adequate covering of toilet plumbing.

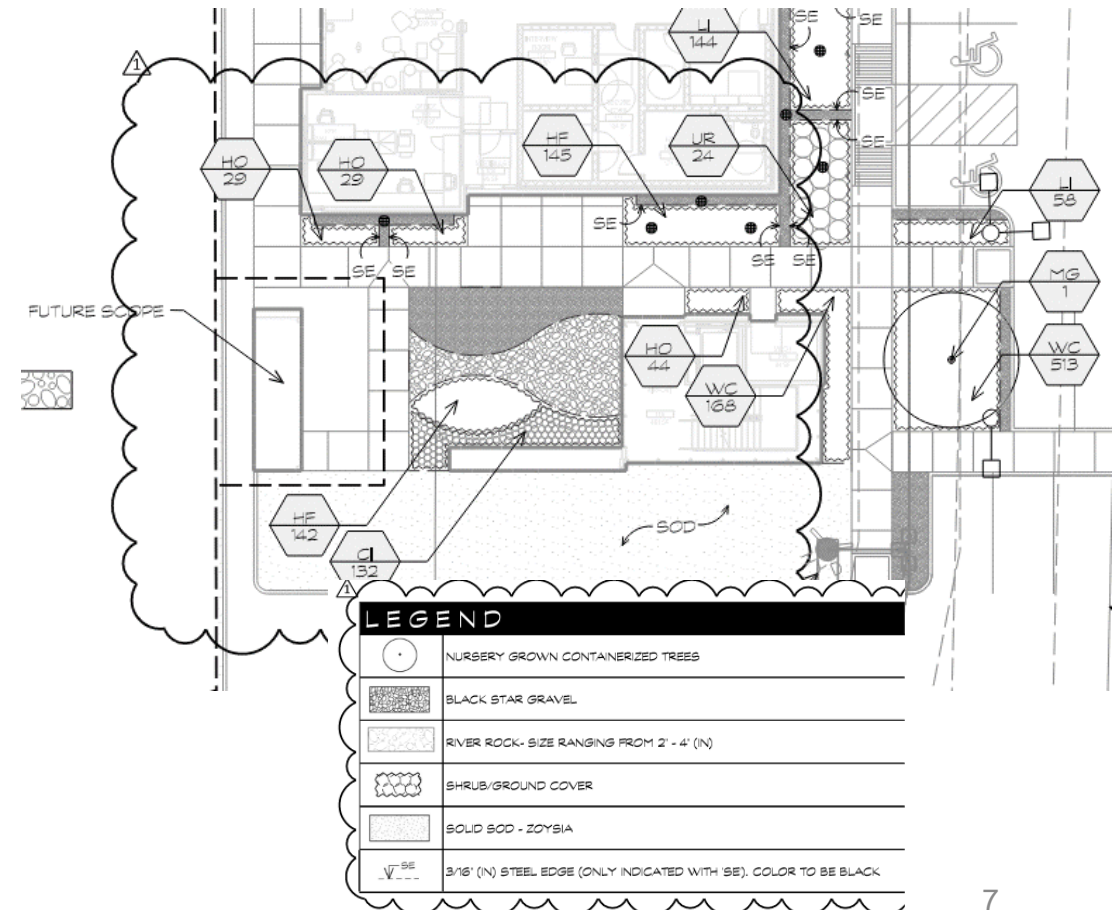
- Revisions were made to the landscape plans and planting designs to include more shade tolerant plants and a more suitable aggregate design for under the buildings shaded breezeway.
- Irrigation designs were updated to match the revisions to the plantings and aggregate design changes.
- The revised plants and aggregate designs were reviewed on-site with the Town Arborist to ensure these changes are in compliance with the Town of Addison standards.

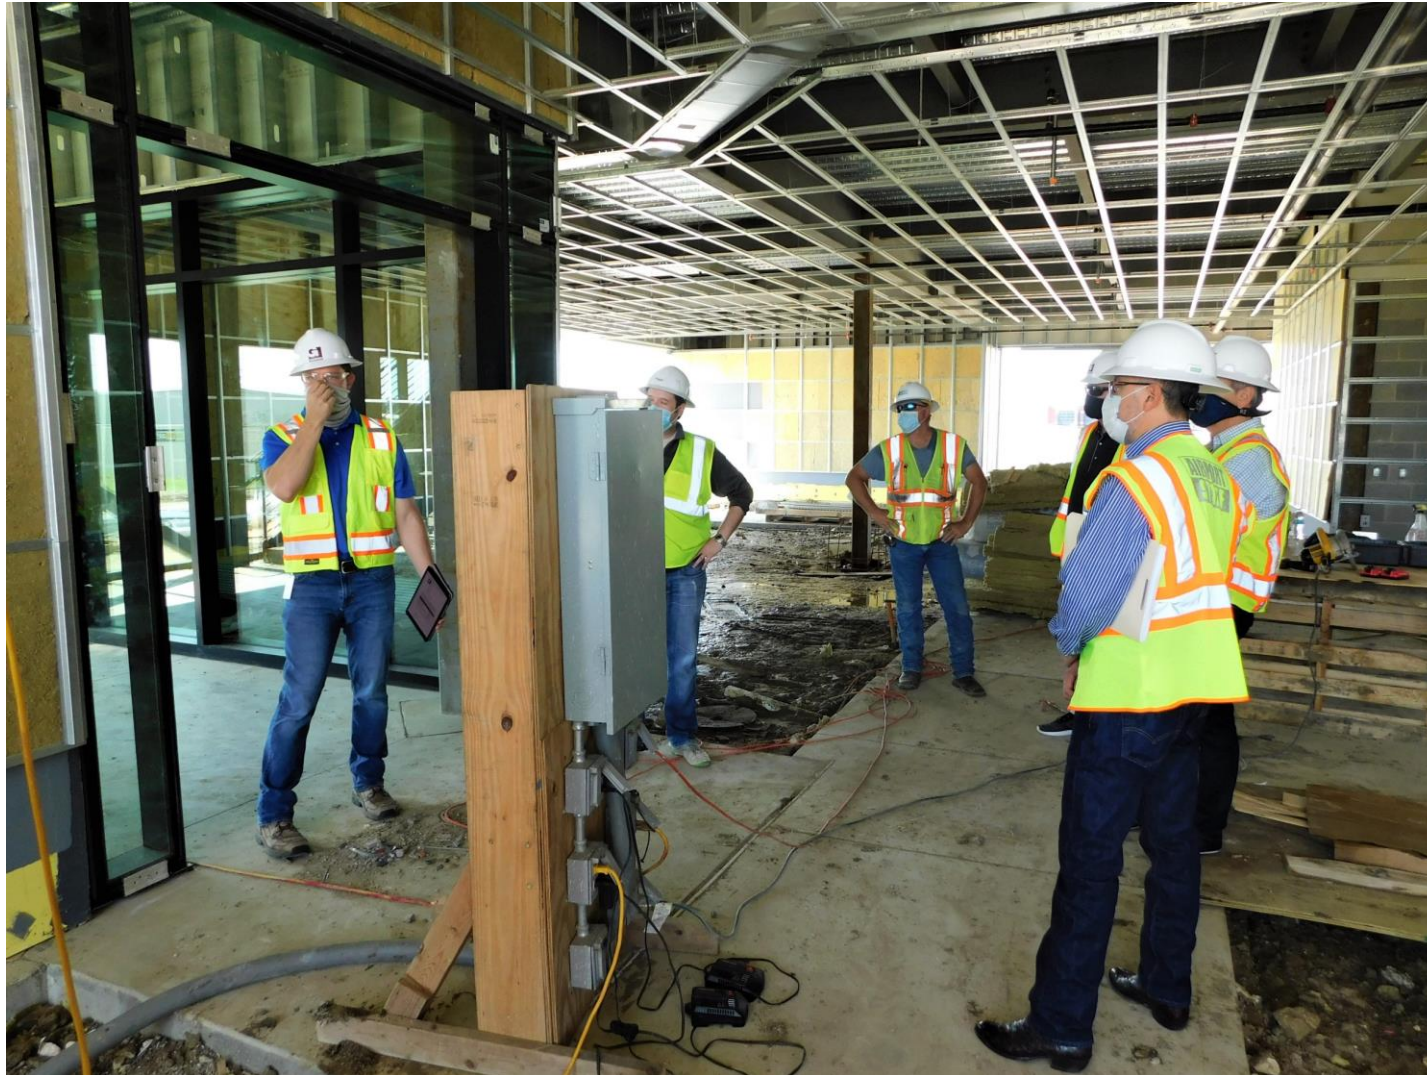
The breezeway area where landscaping changes will be made (September 25, 2020).

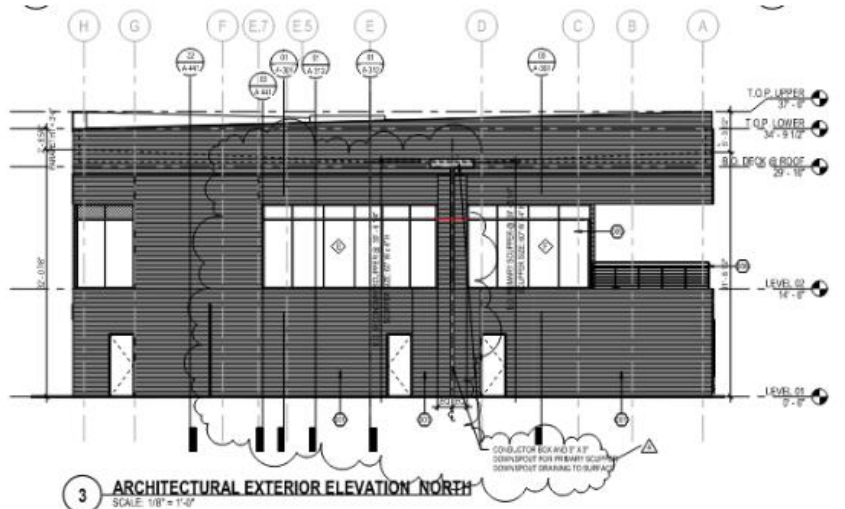
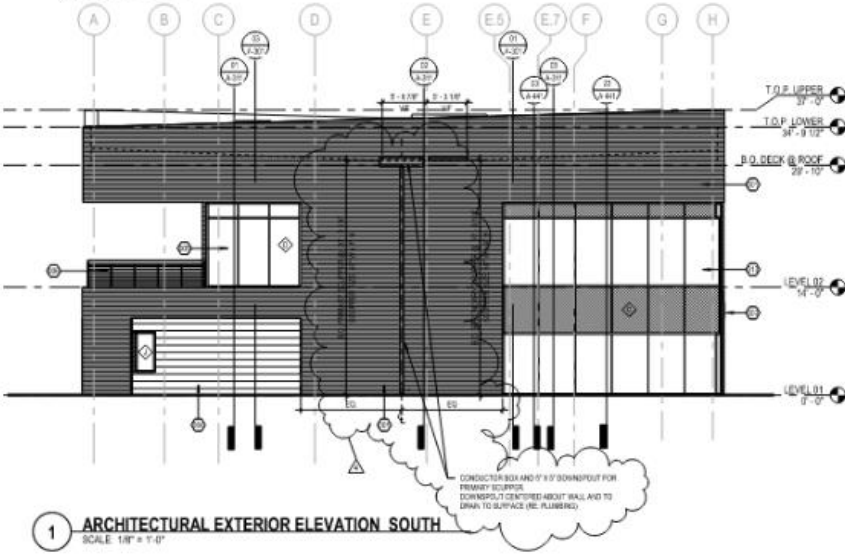
Exterior Elevations from sheet A-201 after the revisions (Current):

- Scupper and Downspout calculations were revised based on the comments received from the Town of Addison Building Permit reviewer.
 - Made scupper openings in the parapet wall larger
 - Add a secondary emergency overflow opening
 - The recessed and hidden downspout was shifted for the primary drain to be exposed on the exterior of the building for the ease of any future maintenance.

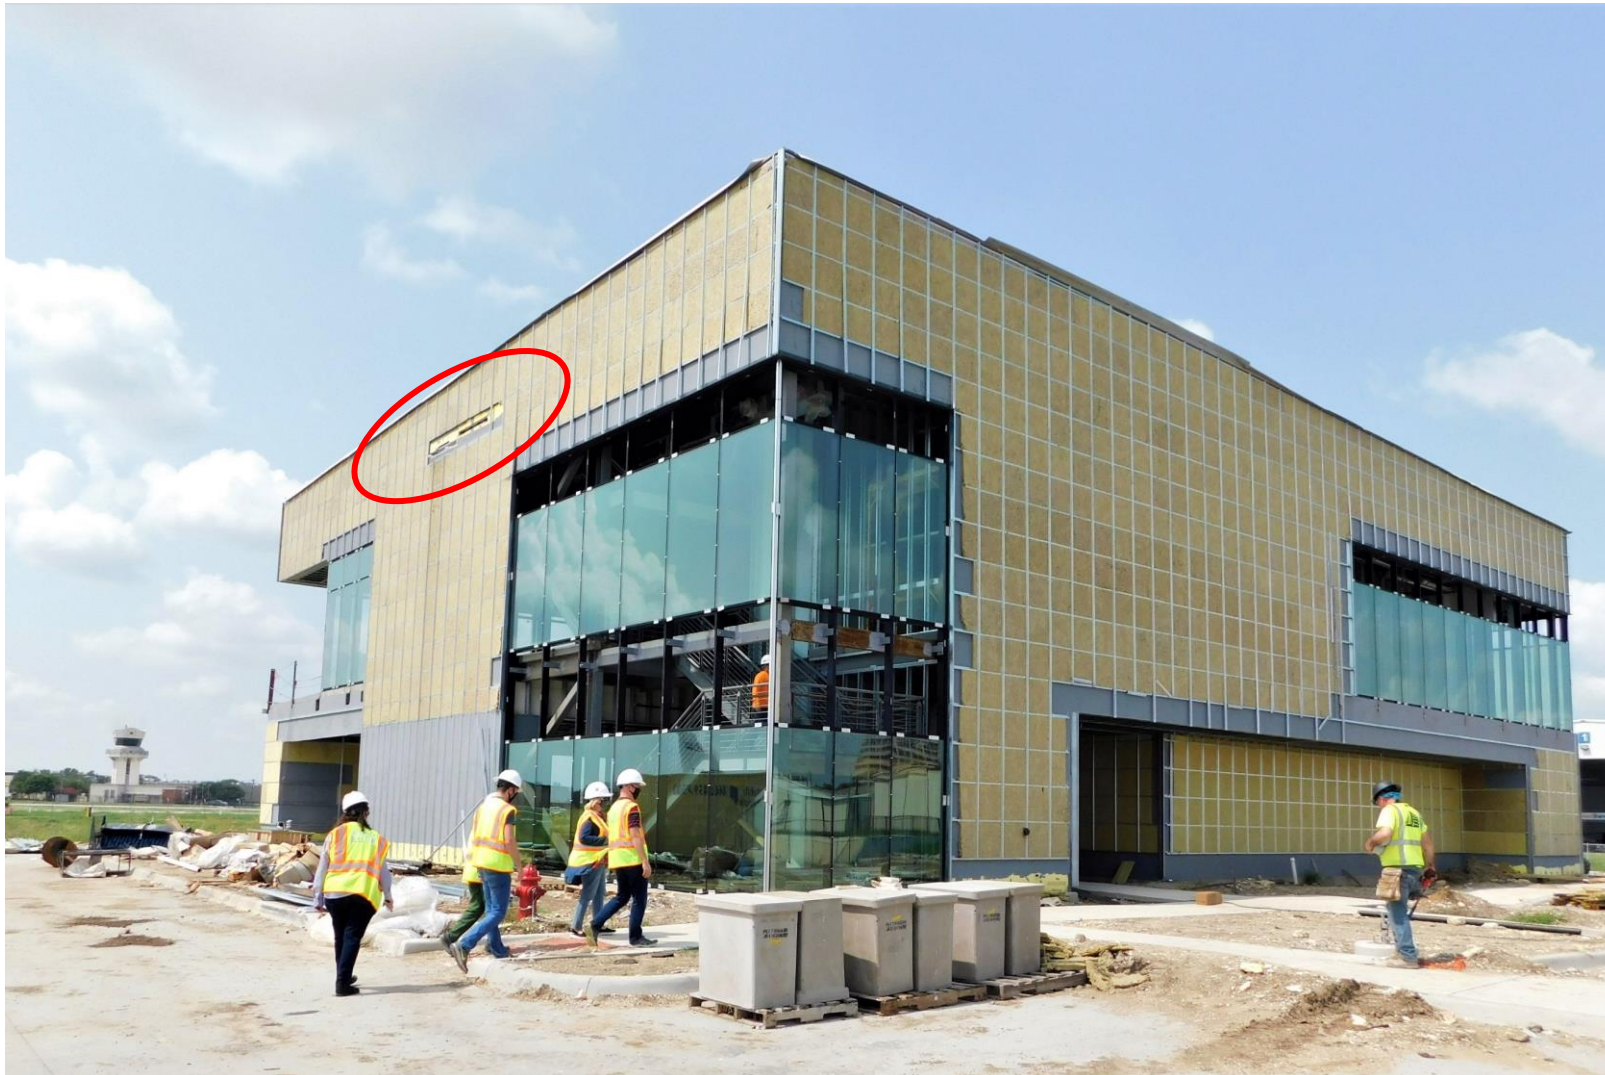
Changes to the scuppers on the south side of the building (September 25, 2020).

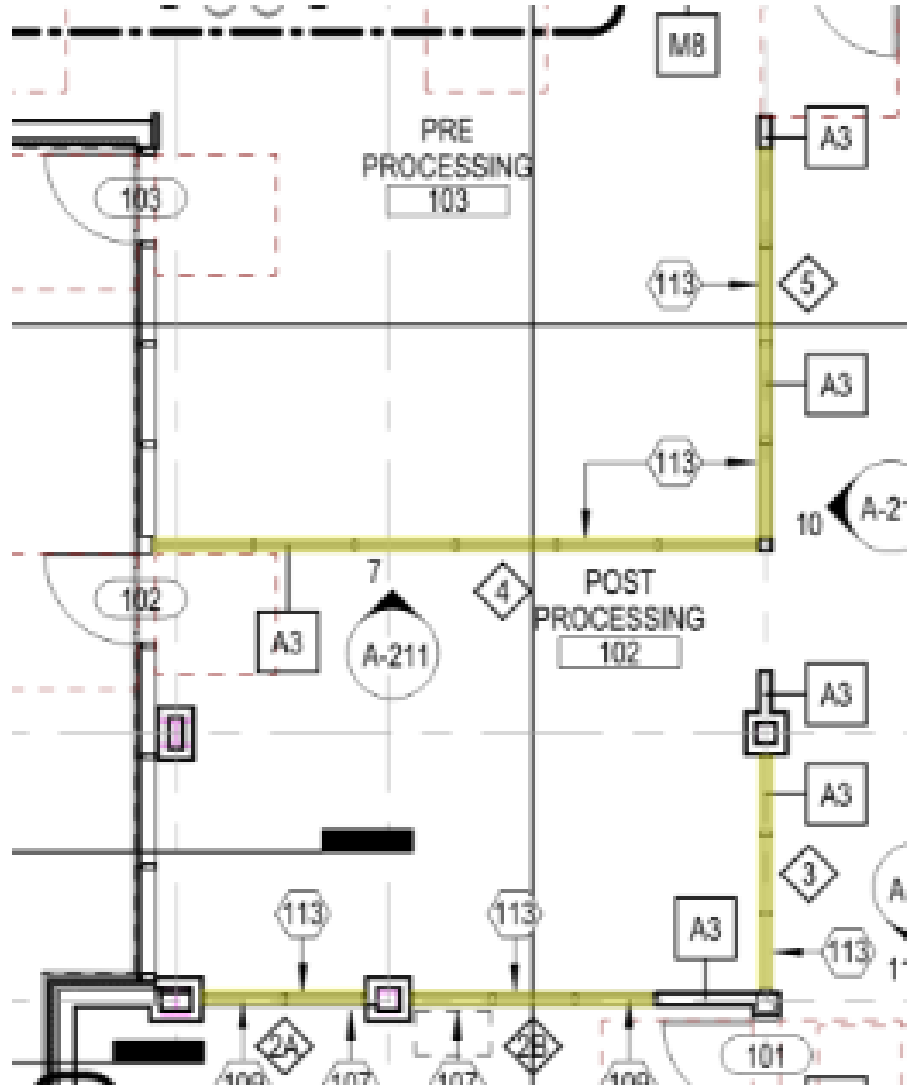
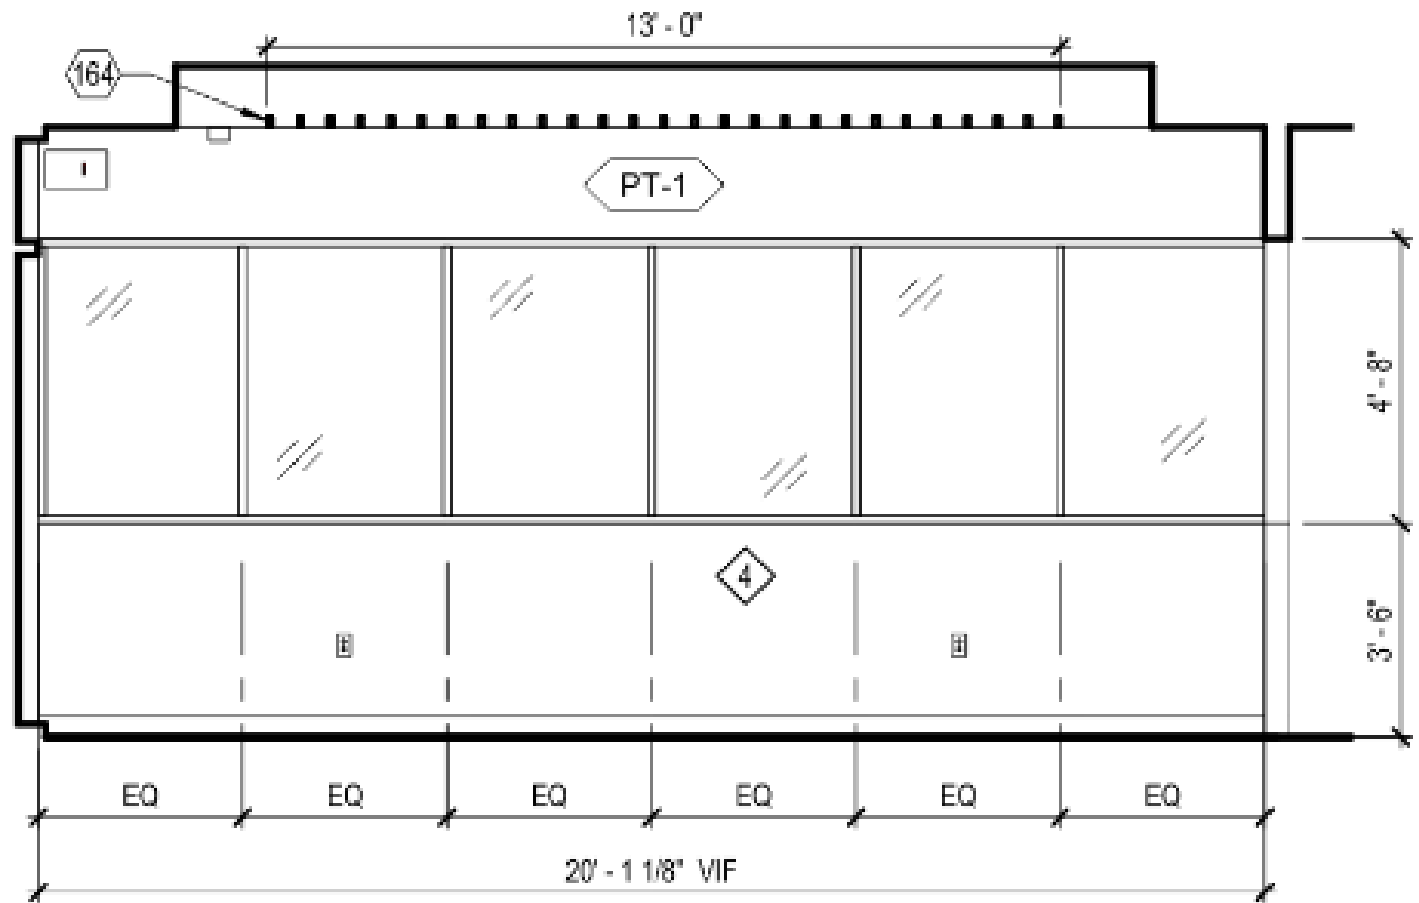
- Drywall framing installed for the walls between the 'Pre Processing 103' and 'Post Processing 102' rooms have glass and aluminum framing that take up the top half of the wall which does not allow the stud framing to run continuously from floor to deck above.
- The wall support elements were installed below the windows inside the 3'-6" tall section of drywall framing to brace the wall from overturning/folding if a lateral force is applied to it in the middle of the wall.

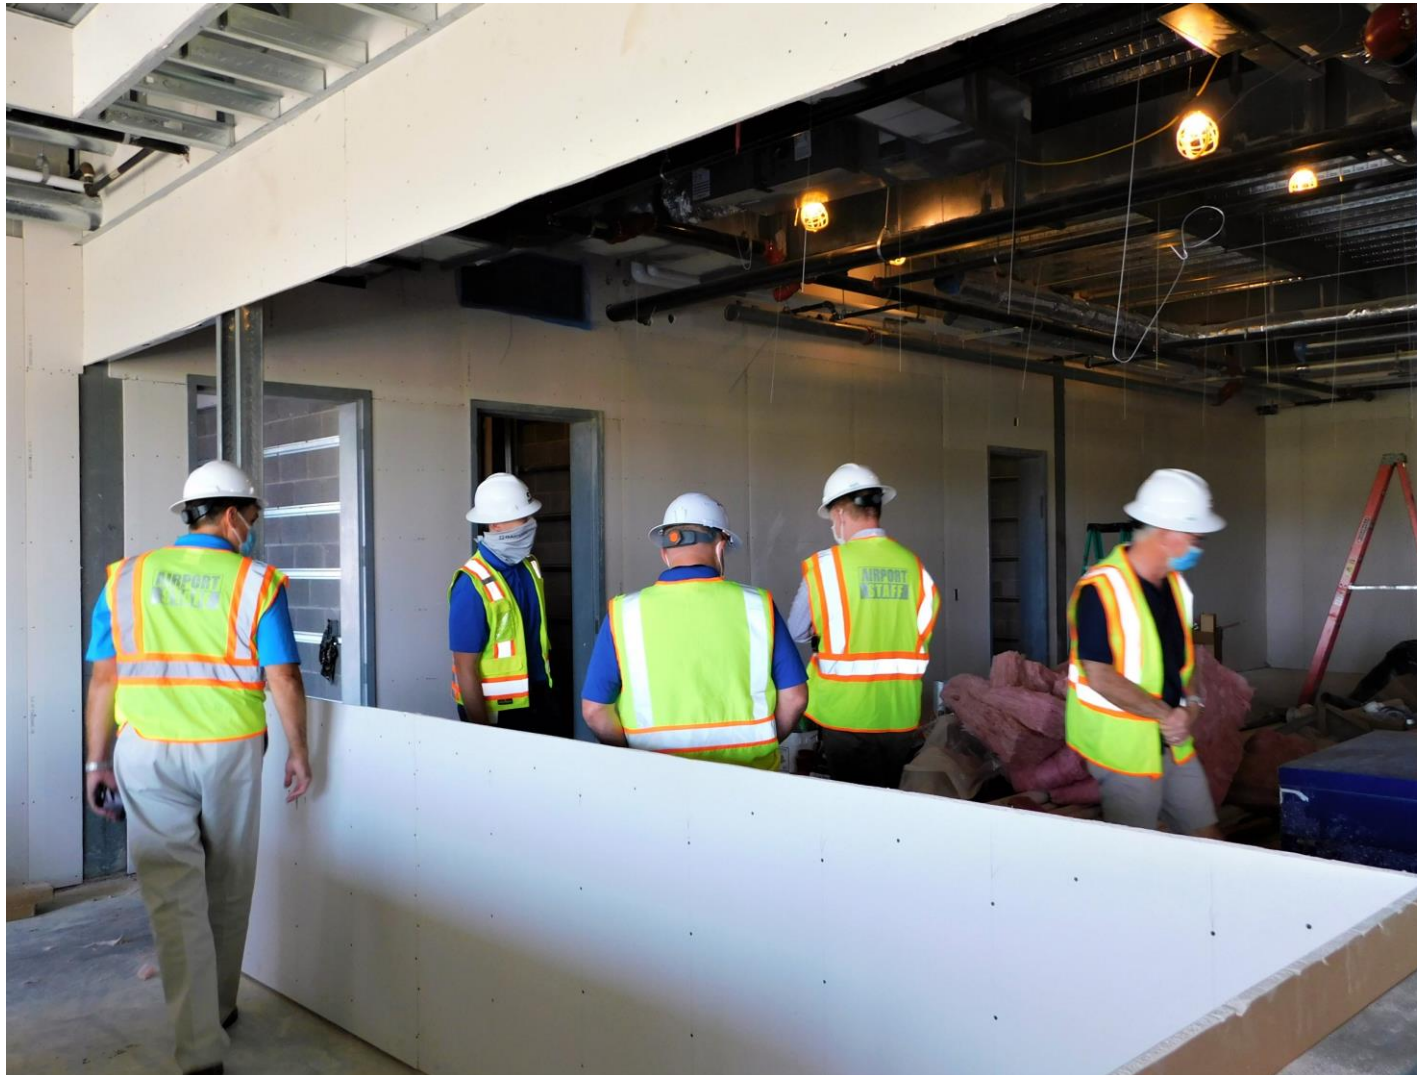
Area of changes to the wall support framing viewed from the post-processing area (September 25, 2020).

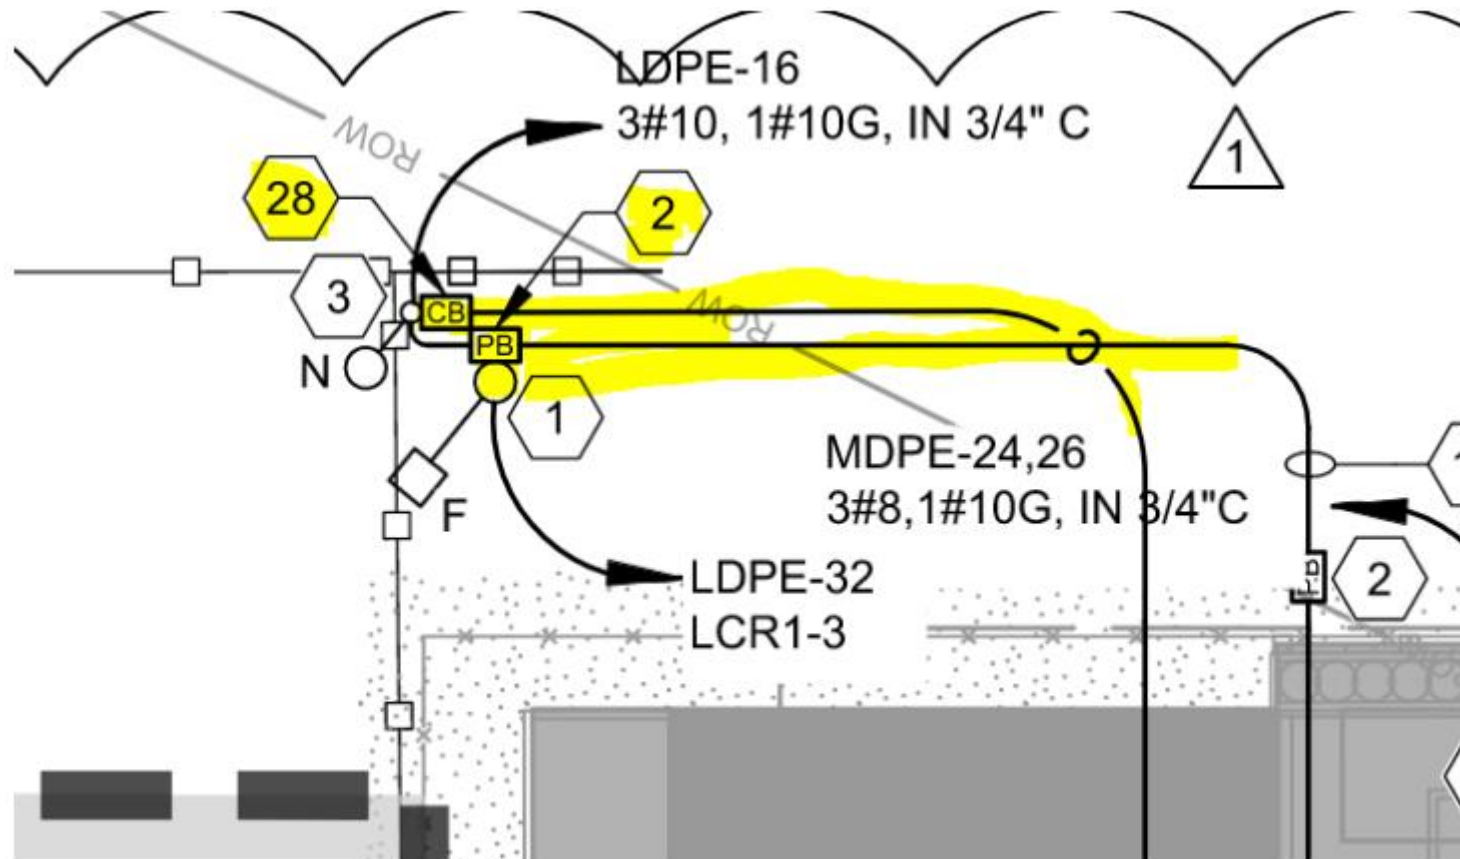
- The proposed Northwest security camera pole is in a location that will conflict with the airside construction.
- The Northwest light and camera pole concrete foundation and erection of the pole will be removed from this contract as a credit.
- The airside project will perform the installation of this light and camera pole with foundation as well as extend the conduit to this proposed pole location.
- JC Commercial will provide the light pole to the airside contractor and will still be responsible for the installation of the wiring, fixtures, and cameras upon completion of the light pole foundation performed by the airside contractor.

From electrical drawing - ES -102. items to be removed from the scope of work as mentioned in the list above.

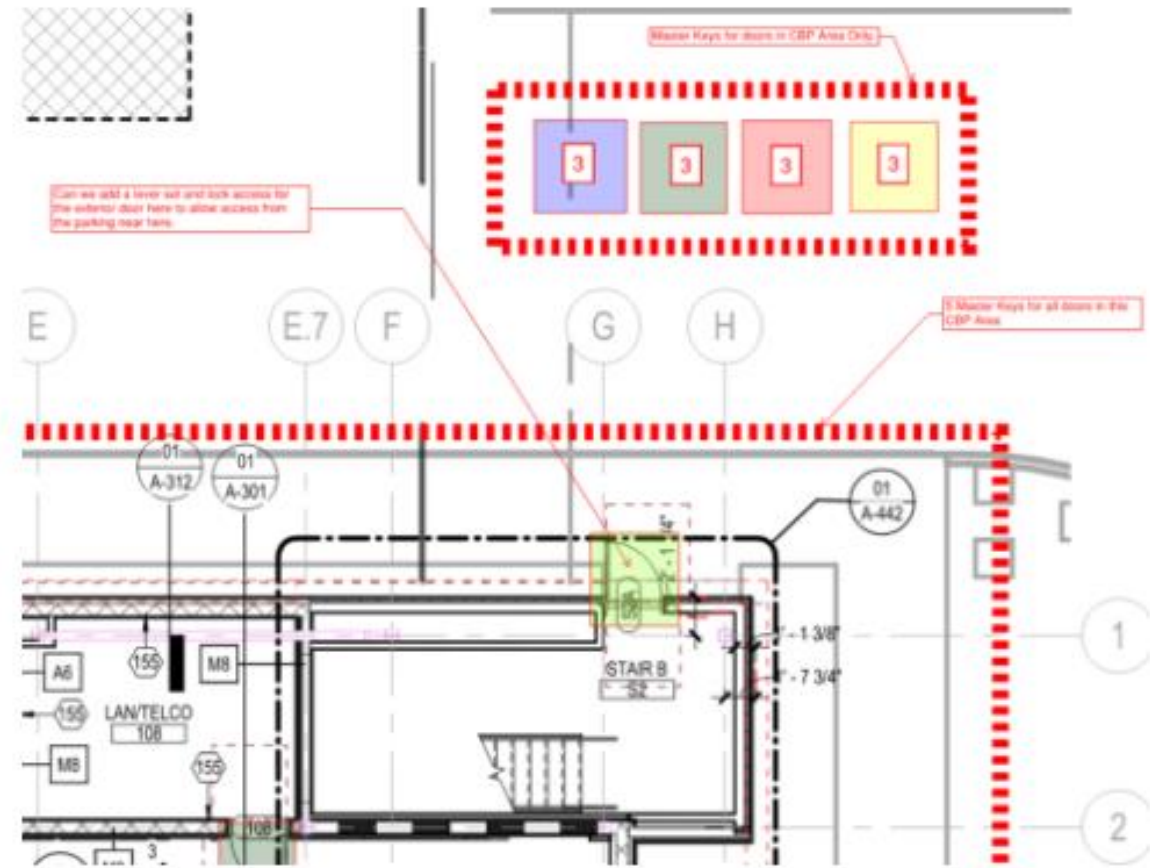
- Airport Staff requested to have access to the building using the exterior stairwell door at the northeast corner of the building for operational purposes.
- Additional hardware ordered for Door S2A for keying and access paths into and out of the building to generate the keying schedule.

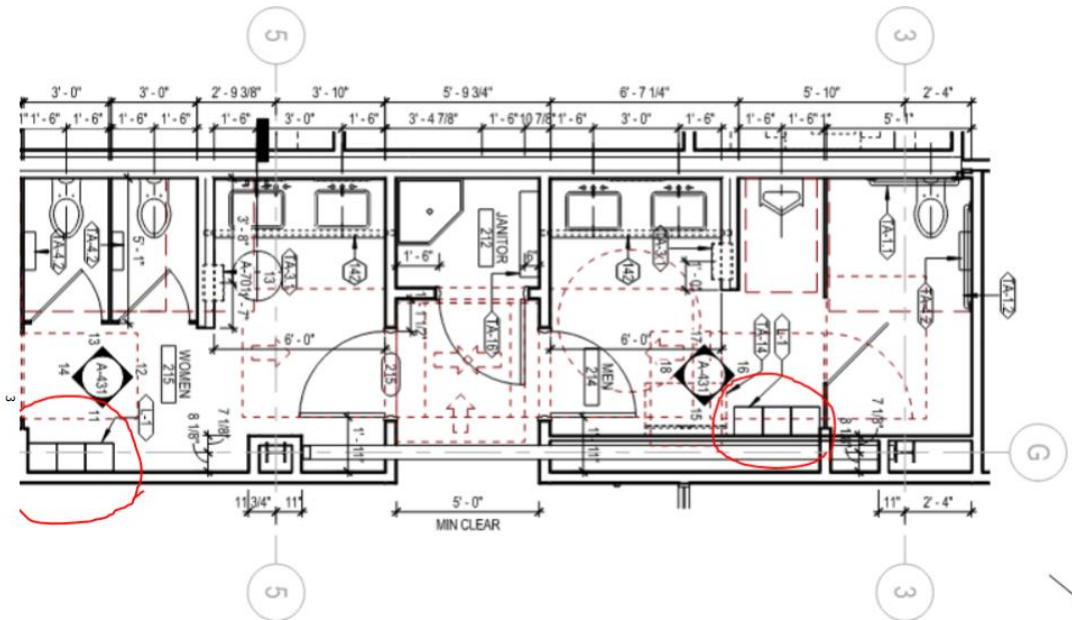
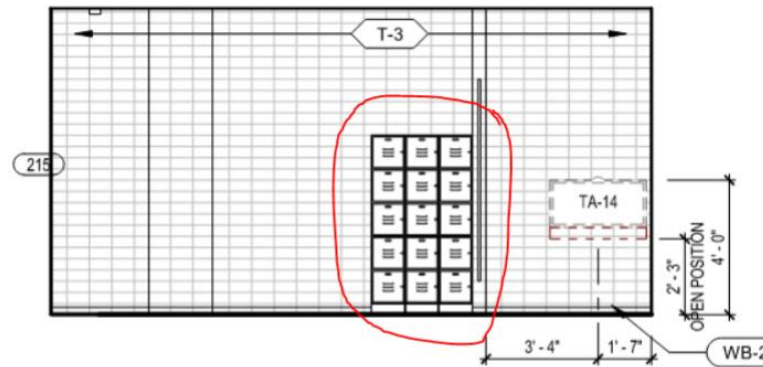
11 ELEVATION @ WOMEN'S RR 215 - EAST
SCALE: 1/4" = 1'-0"

- Lockers Credit to remove the small metal lockers from the project scope in the gang restrooms on the second floor.
